THE UNIVERSITY OF
NEW MEXICO.

Annual Stormwater Report

December 2023 | MS4 Permit # NMR04A000

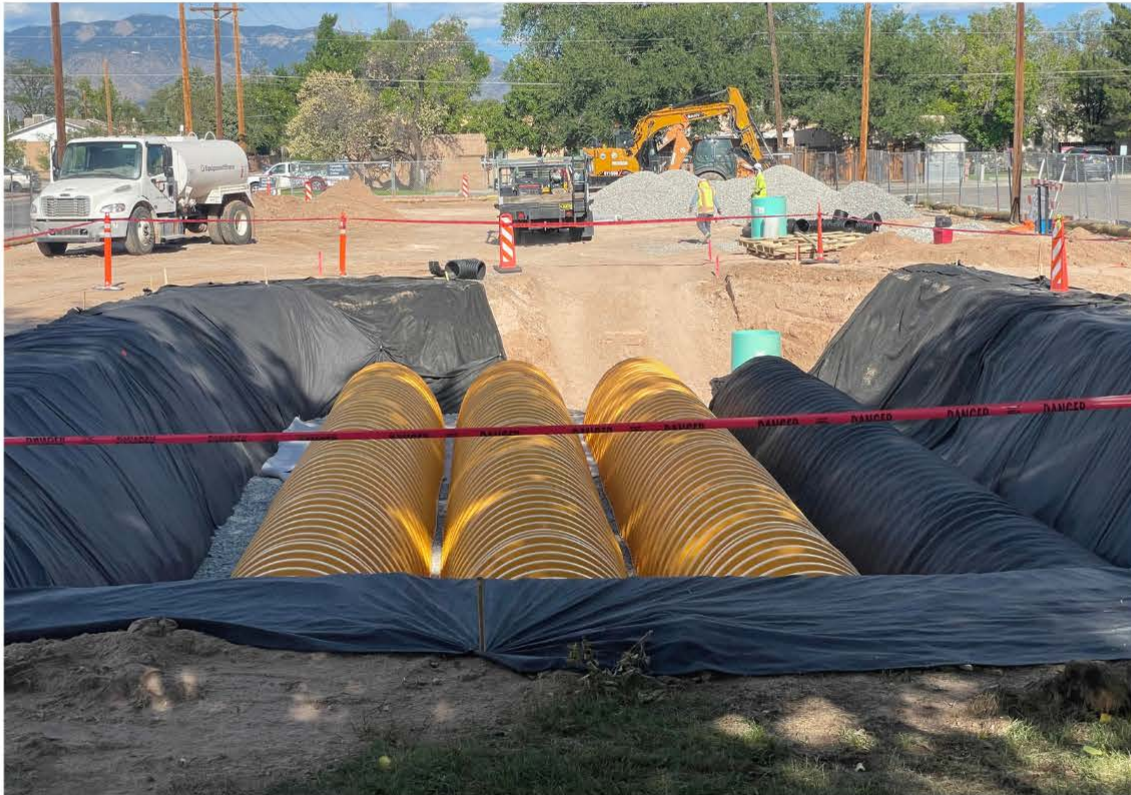
A NEWLY INSTALLED RAINWATER INFILTRATION SYSTEM UNDER THE PARKING LOT OF THE REDESIGNED CRISIS TRIAGE CENTER AT UNM HEALTH SCIENCES.
