OIL SPILL PREVENTION, CONTROL, & COUNTERMEASURE (SPCC) PLAN

April 2024
(V.2022.A1)

THE UNIVERSITY OF
NEW MEXICO®

ALBUQUERQUE CAMPUS

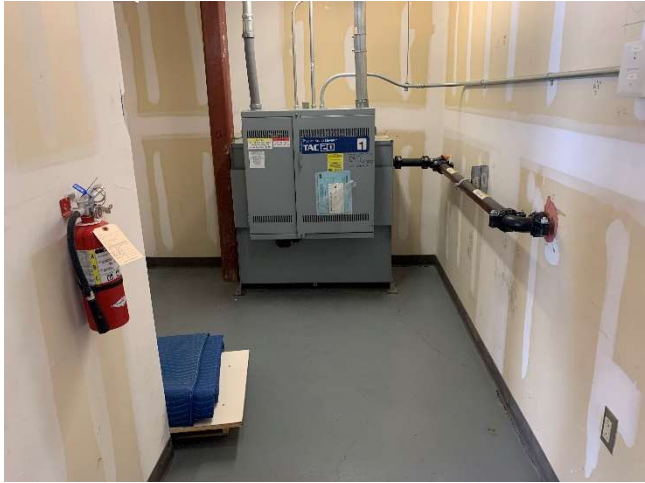
Castetter Hall – Hydraulic Elevator #3: 120-gallon, hydraulic oil reservoir (24 May 2022).

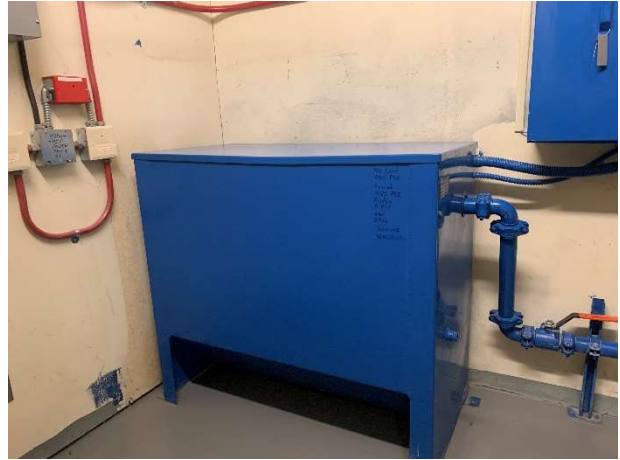
Castetter Hall – Hydraulic Elevator #2: 120-gallon, hydraulic oil reservoir (24 May 2022).

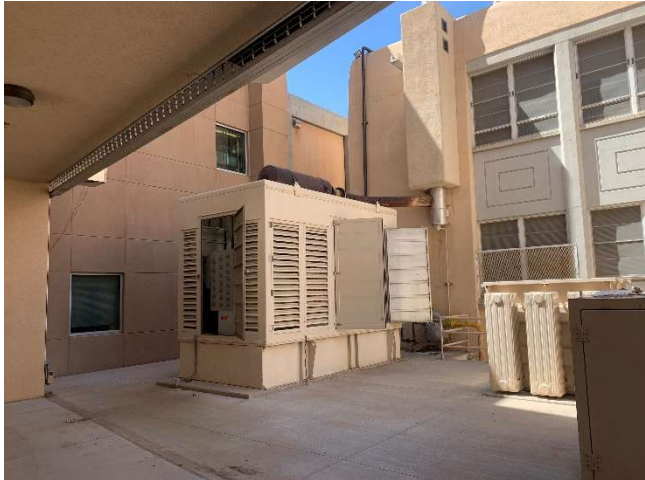
Castetter Hall – 21-AST-1, 1,075-gallon diesel emergency generator tank (24 May 2022).

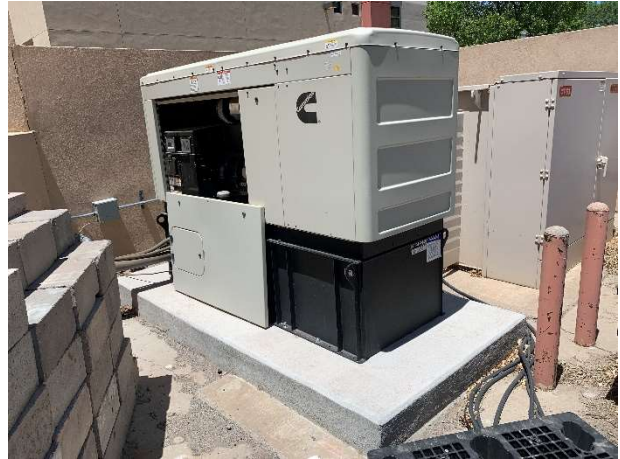
Centennial Sciences and Engineering Library – 46-AST-1, 132-gallon diesel emergency generator tank (24 May 2022).

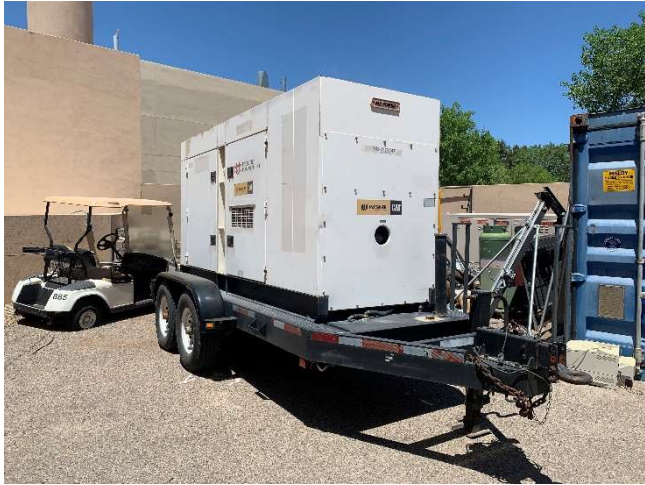
Centennial Sciences and Engineering Library – 46-AST-BACKUP, 79-gallon portable generator tank (24 May 2022).

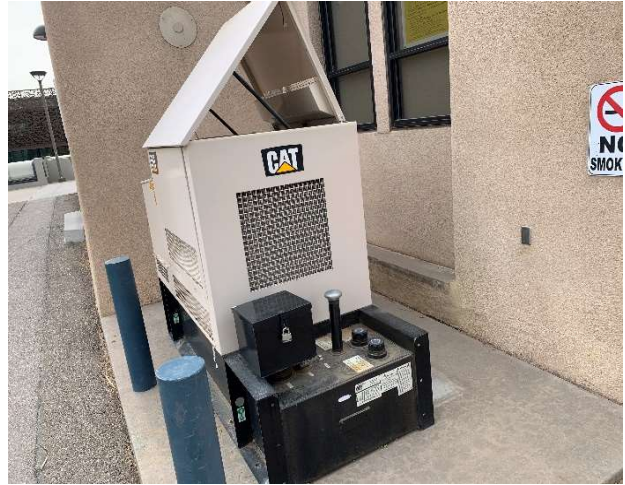
Economics Hall – 57-AST-1, 140-gallon diesel emergency generator tank (24 May 2022).

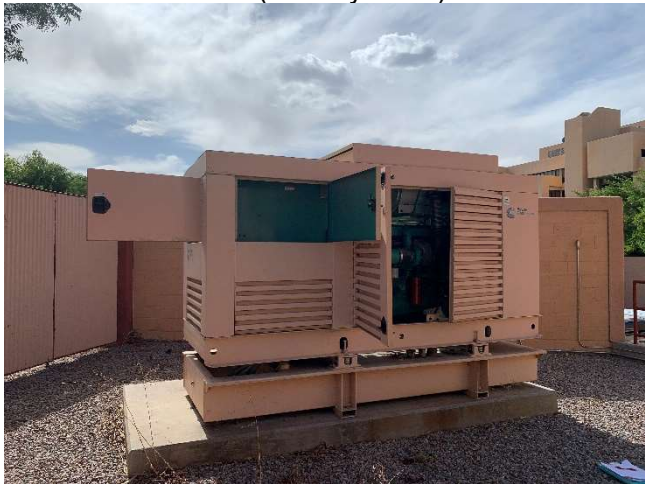
Student Union Building – 60-AST-1 250-gallon diesel emergency generator tank (24 May 2022).

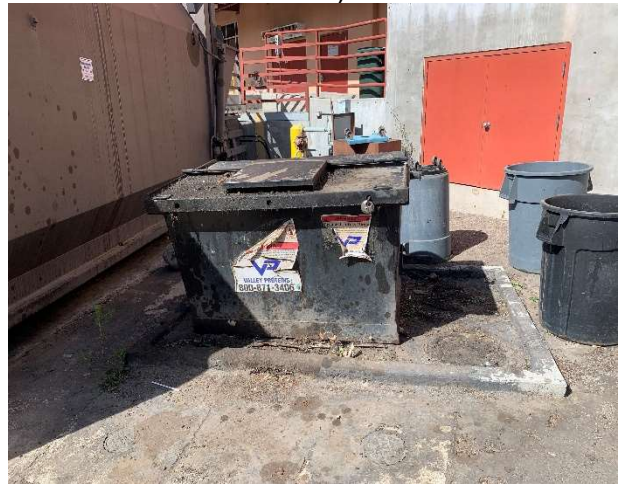
Student Union Building – 60-AST-2 150-gallon cooking grease tank (24 May 2022).

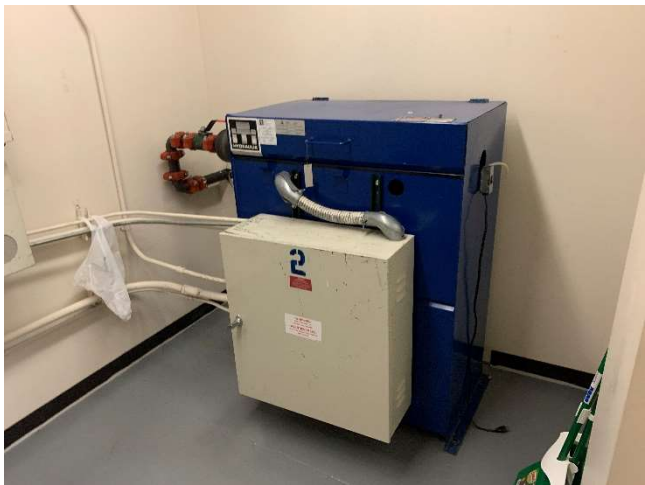
Student Union Building - 120-gallon, hydraulic oil reservoir #2 (24 May 2022).

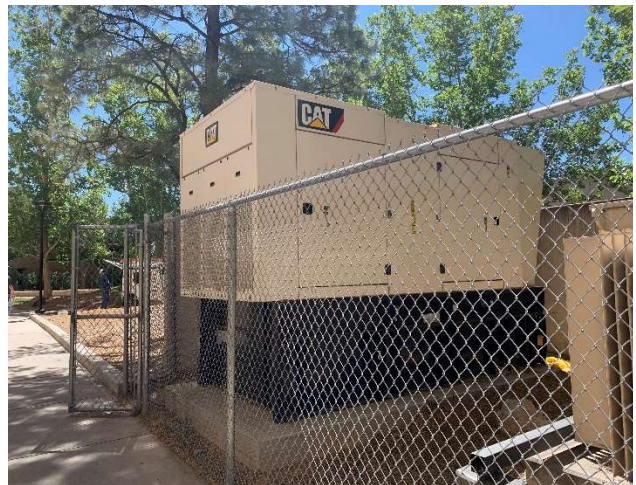
Popejoy Hall – 62-AST-1, 660-gallon diesel emergency generator tank (photo dated 24 May 2022).

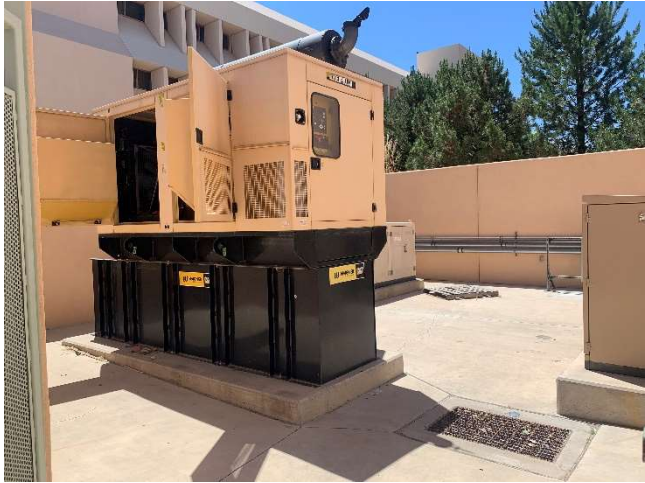
Centennial Engineering Center – 112-AST-1, 660-gallon emergency generator tank (25 May 2022).

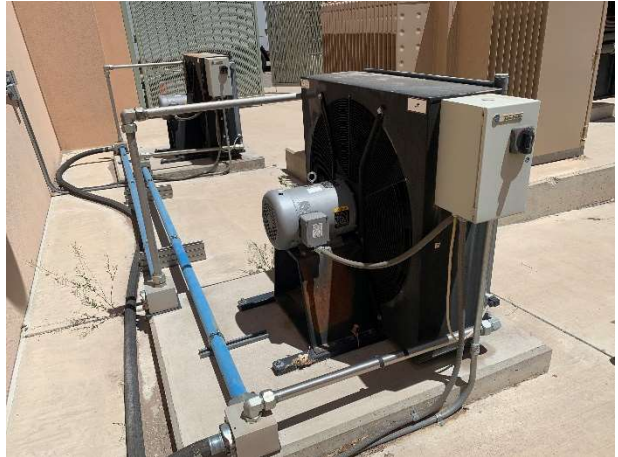
Centennial Engineering Center – 112-AST-1, pump set with audible alarm (25 May 2022).

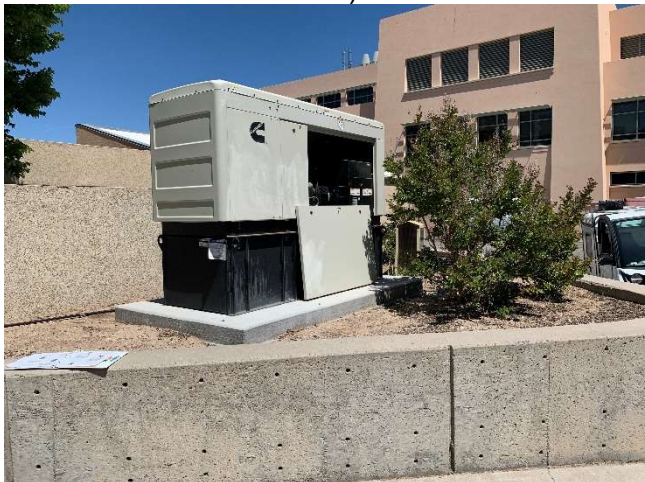
Mechanical Engineering – 122-AST-1 132-gallon diesel emergency generator tank (25 May 2022).

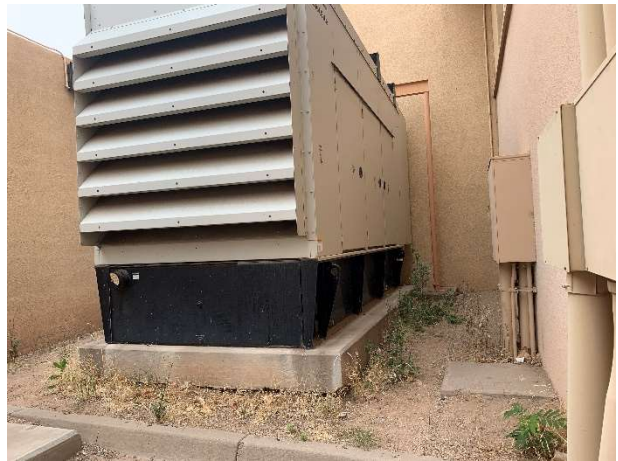
Information Technologies Building – 153-AST-1, 850-gallon diesel emergency generator tank (25 May 2022).

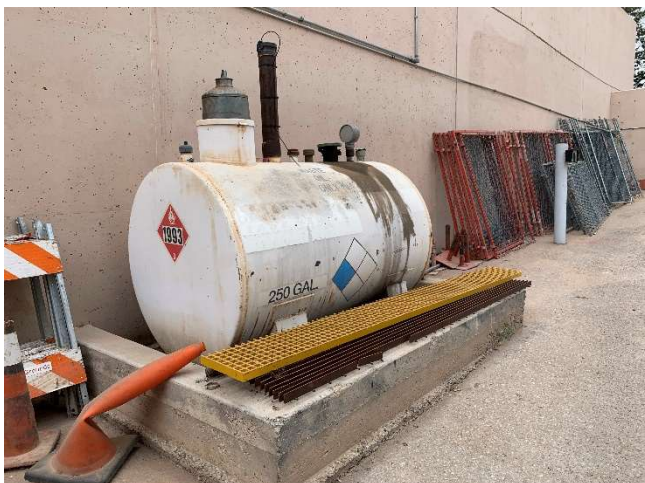
Lomas Chiller Plant – 194-AST-1 250-gallon, waste oil tank (25 May 2022).

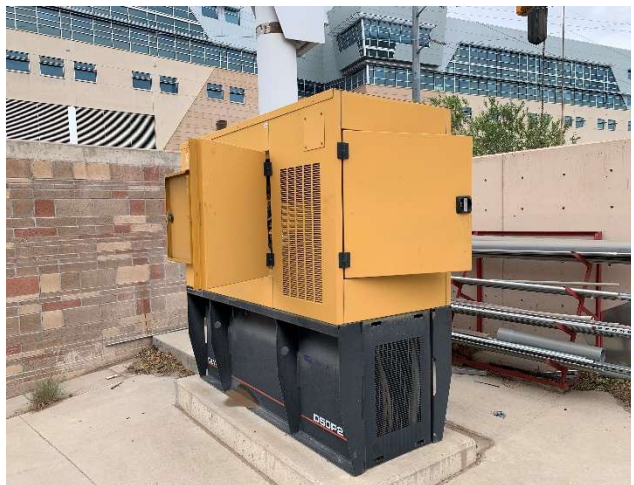
Lomas Chiller Plant – 194-AST-1 147-gallon, emergency generator tank (photo dated 25 May 2022).

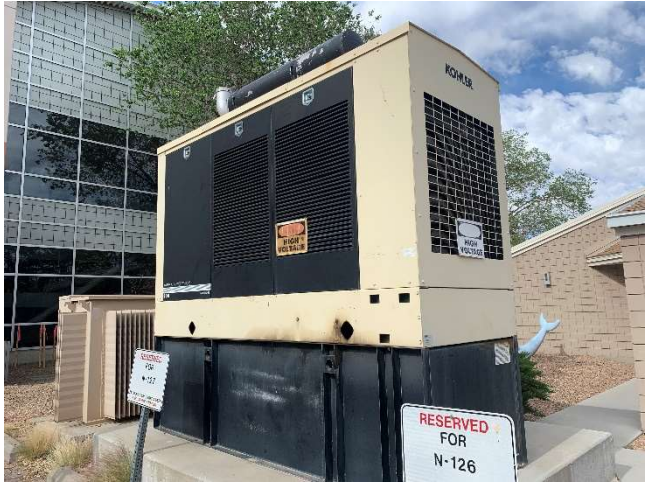
Research Incubator Building – 205-AST-1,
750-gallon emergency generator tank (24 May 2022).

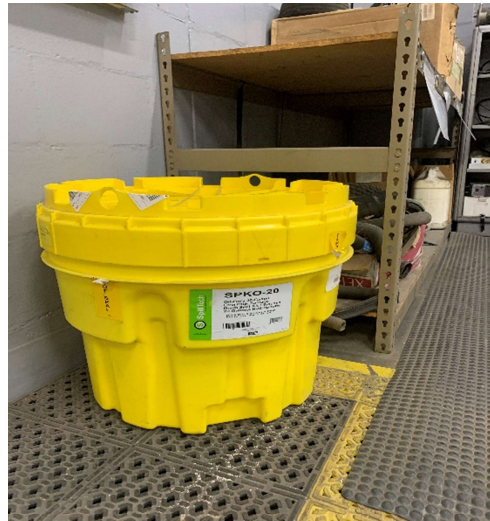
Automotive Center – 20-gallon spill kit (23 May 2022).

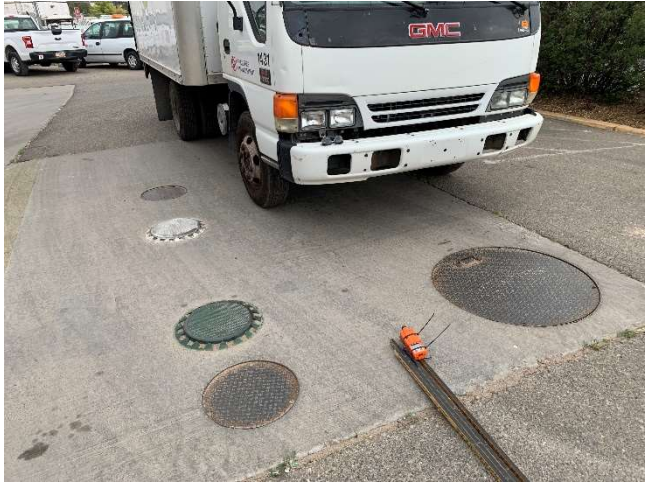
Automotive Center – 216-AST-1A/1B 5,170-gallon vaulted compartment tank (23 May 2022).

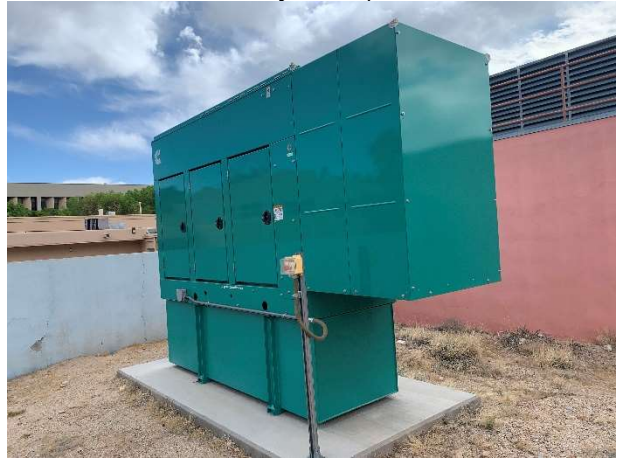
Clinical and Translational Science Center – 227-AST-1, 550-gallon emergency generator tank (24 May 2022).

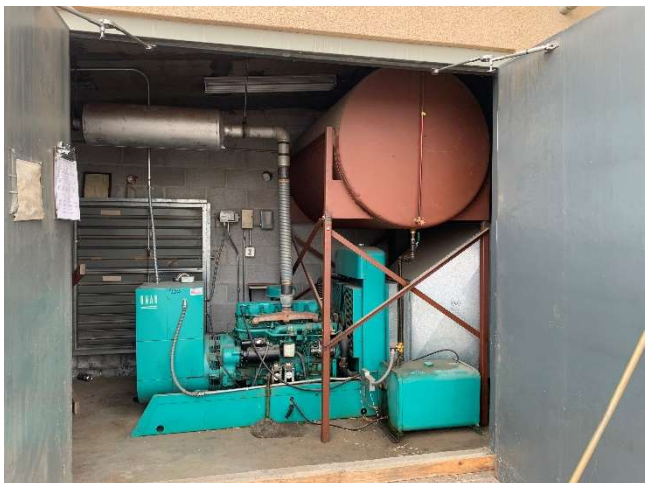
Nursing and Pharmacy – 228-AST-1, 648-gallon, stilted emergency generator tank (23 May 2022).

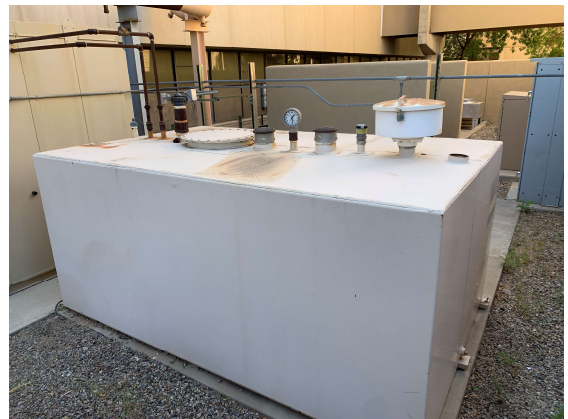
Biological Research Facility and Cancer Research Facility (BRF-CRF) – 229-AST-1, 2,019-gallon diesel supply tank (24 May 2022).

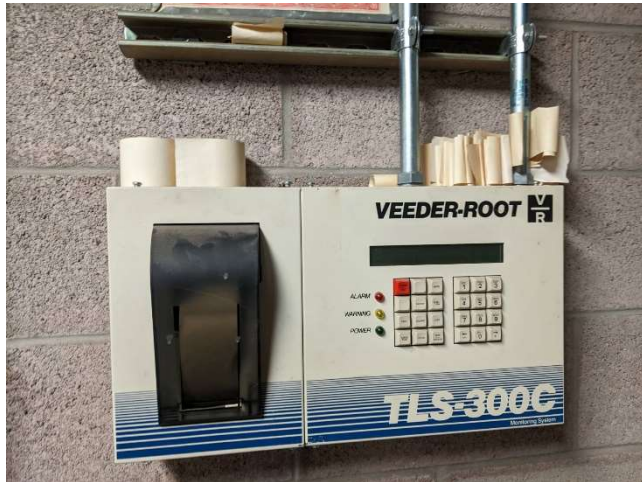
Cancer Research Facility – Veeder-Root Automatic Tank Gauge system (24 May 2022).

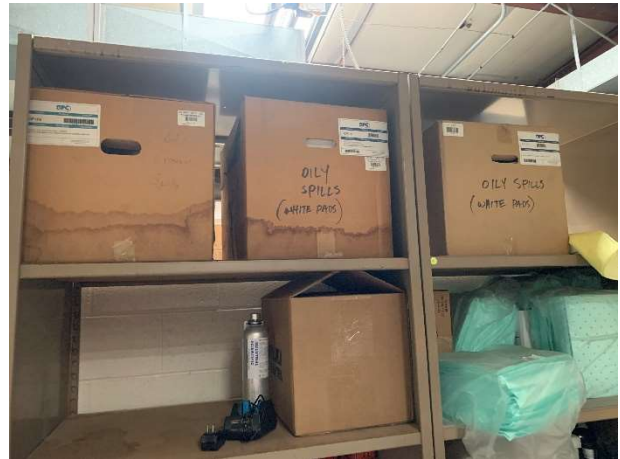
EHS (233) – Spill response equipment storage (23 May 2022).

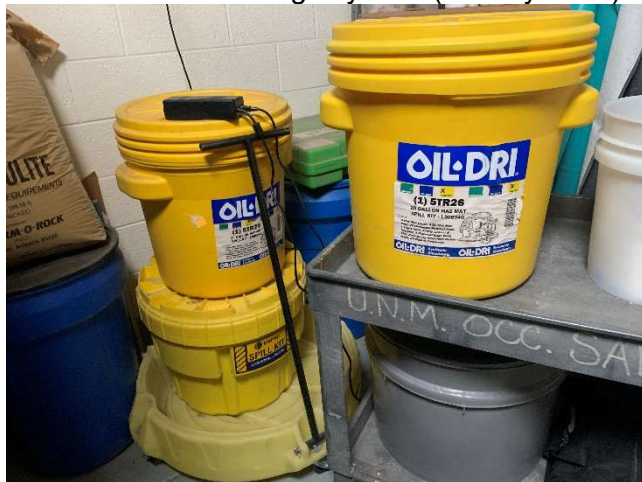
EHS (233) – Spill response equipment storage (23 May 2022).

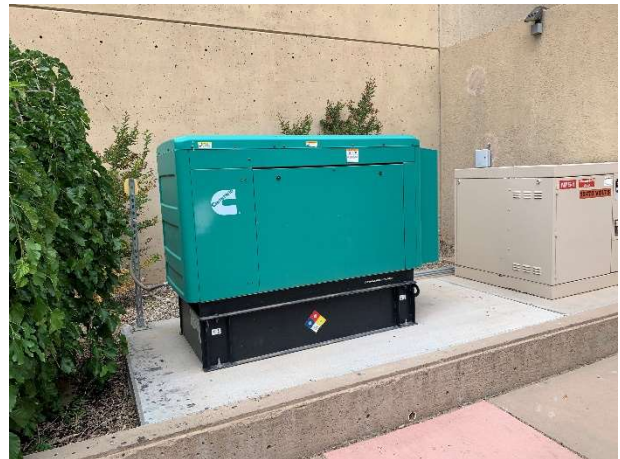
Health Sciences Library and Informatics Center – 234-AST-1, 50-gallon emergency generator tank (24 May 2022).

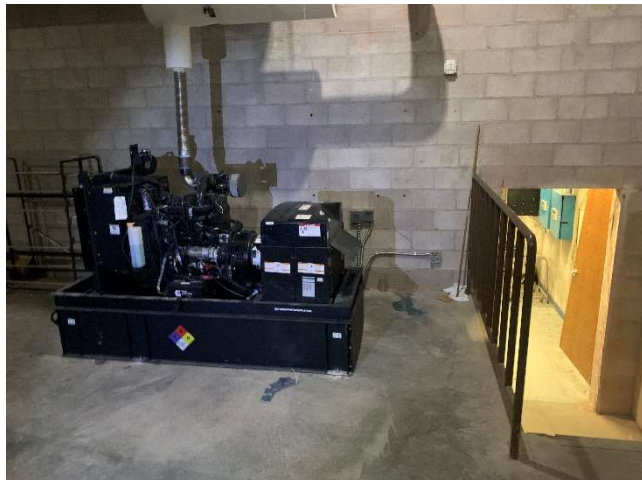
Family Practice Building – 248-AST-1, 76-gallon, emergency generator tank (24 May 2022).

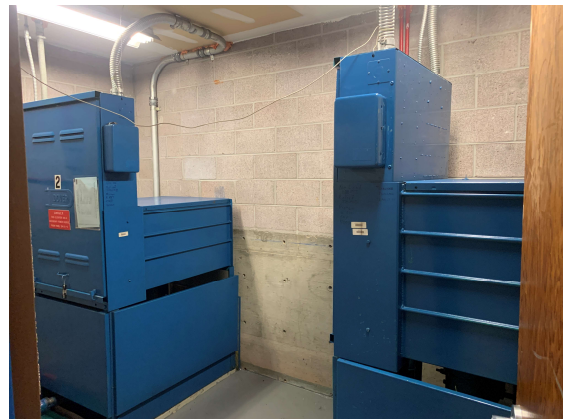
Family Practice Building – Hydraulic elevator machine room with two (2) 120-gallon reservoirs (photo dated 24 May 2022).

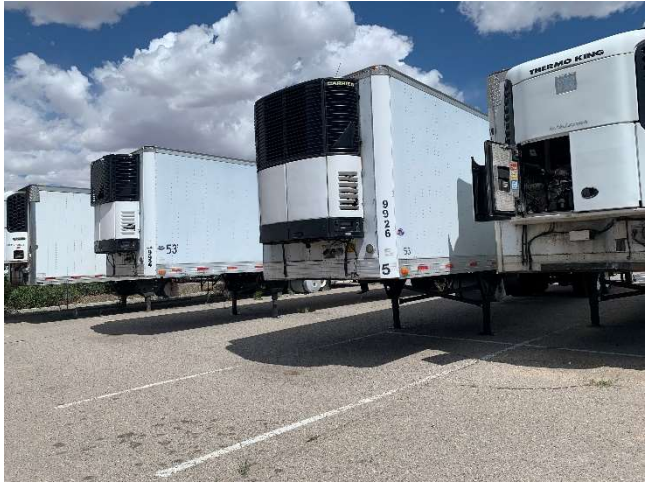
OMI Refrigeration trucks – ~10-gallon portable tanks (24 May 2022).

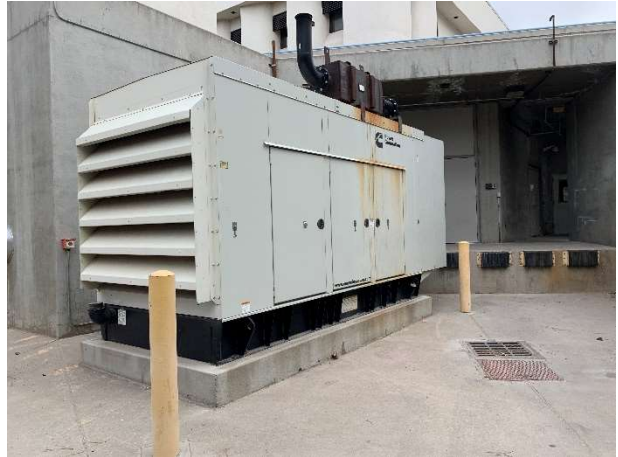
Innovation Discovery Training Complex – 289-AST-1, 500-gallon emergency generator tank (24 May 2022).

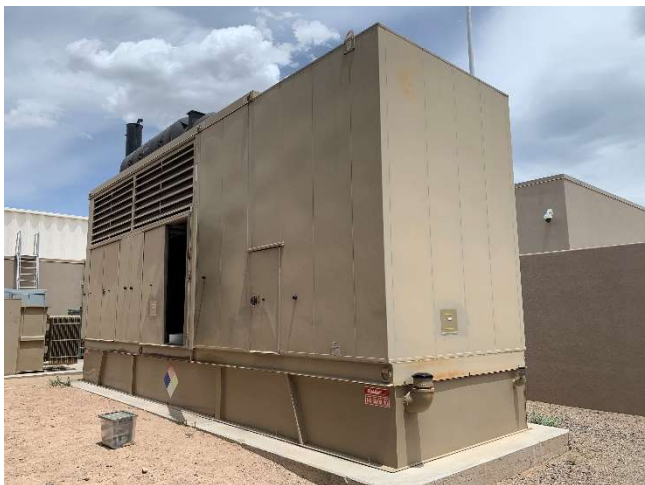
The Pit (University Arena) – 302-AST-1, 2,635-gallon emergency generator tank (23 May 2022)

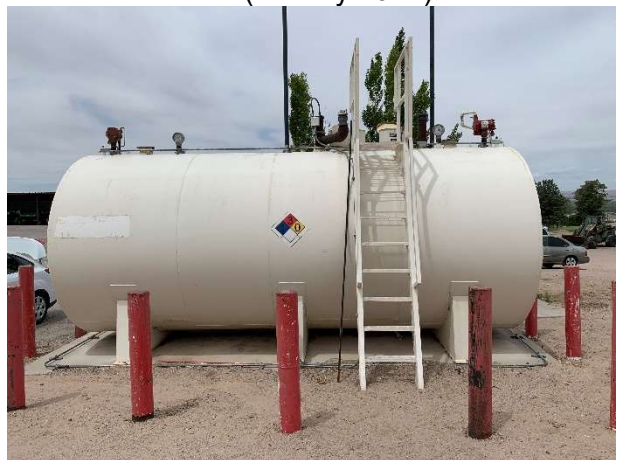
South Golf Course Maintenance Building – 304-AST-1A/1B, 5,000-gallon compartmented supply tank (24 May 2022).

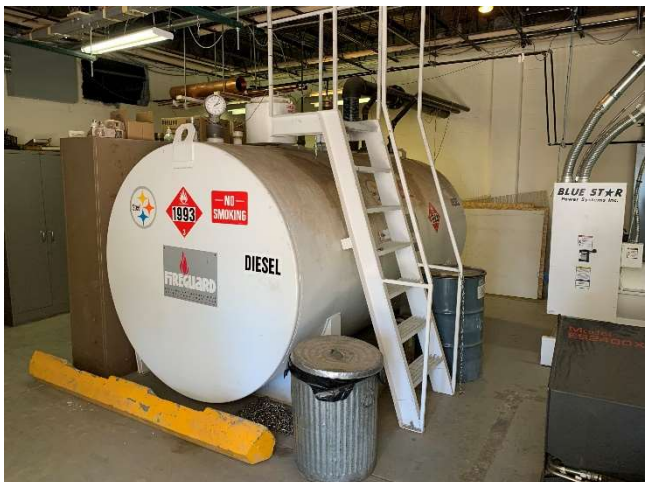
Sandia Crest KNME Transmitter – SC-AST-1, 1,500-gallon, generator supply tank (25 May 2022).

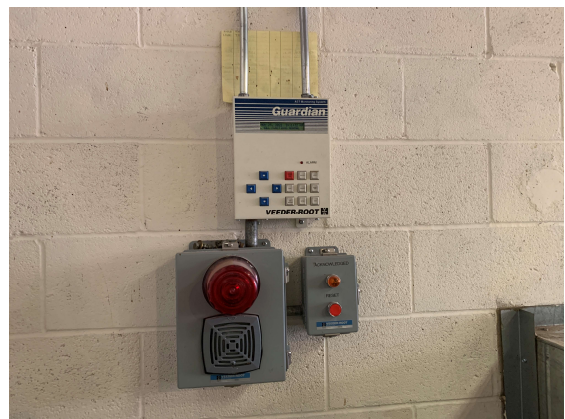
Sandia Crest KNME Transmitter – Veeder-Root Automatic Tank Gauge system (photo dated 25 May 2022).

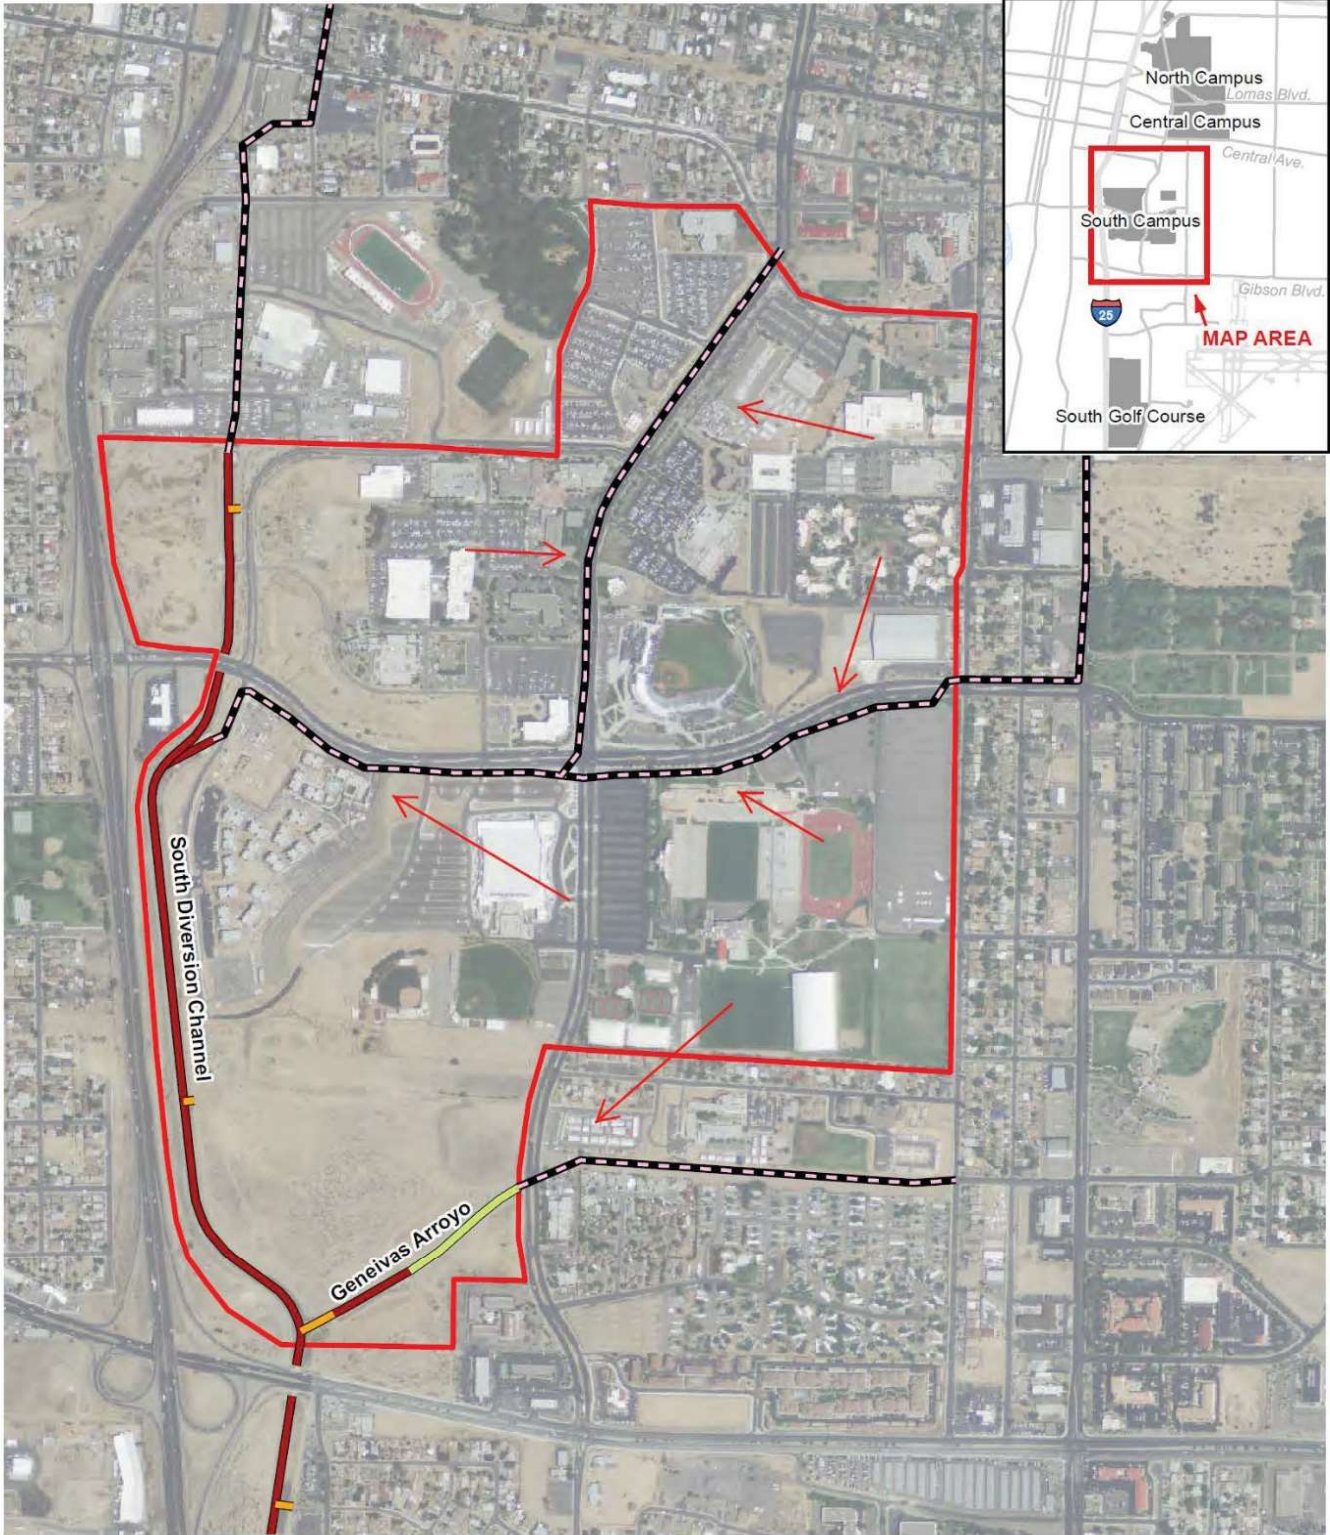
2011 NAIP aerial photography from USDA.

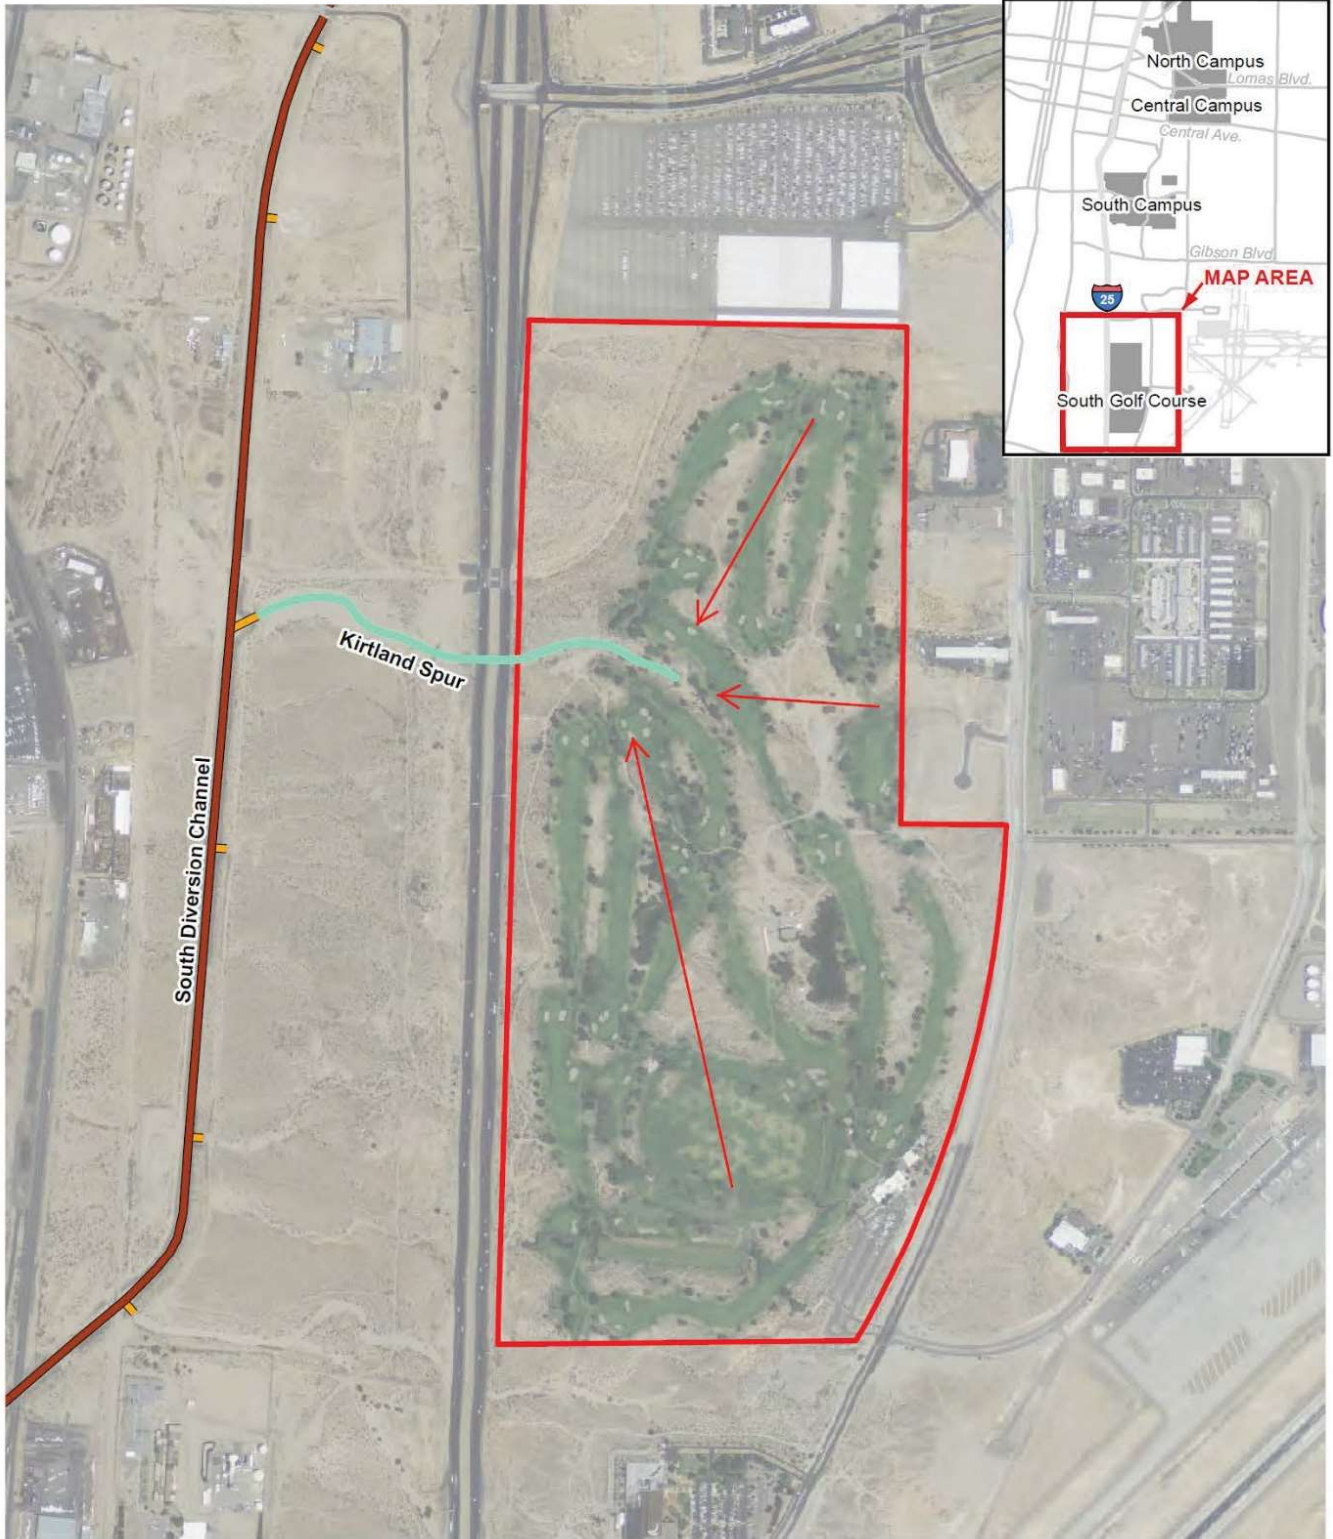
UNM SPCC
South Campus

2011 NAIP aerial photography from USDA.
