# Annual Report Format

## National Pollutant Discharge Elimination System Stormwater Program MS4 Annual Report Format

UNIVERSITY OF NEW MEXICO

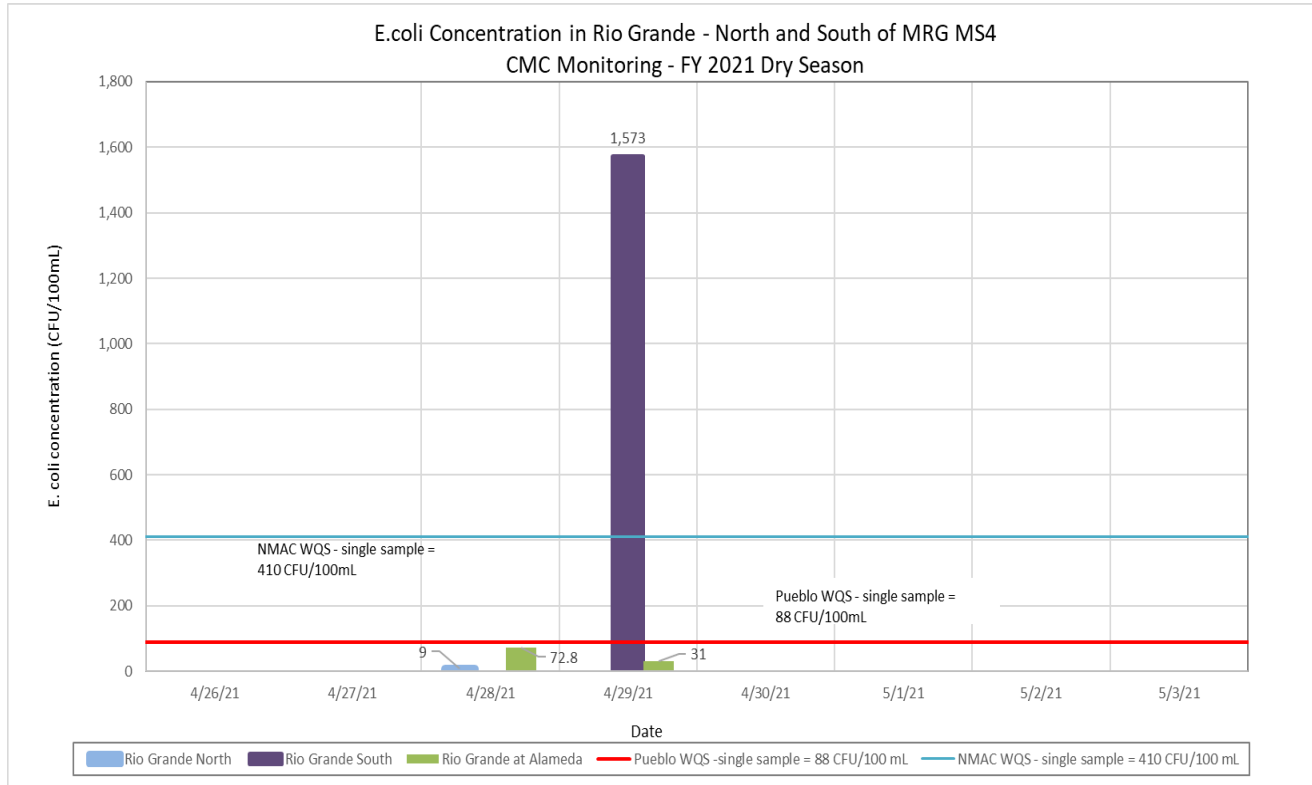
**Figure 2: E. coli Results in Rio Grande CMC Monitoring – FY 2021 Dry Season**

In addition, the CMC added an E. coli sample point in the Rio Grande at Alameda. This added analysis point was based on discussions with NMED in February 2017 on collecting actual data at the stream segment divide verses using an area percentage (as defined in the TMDL) for E. coli loading calculations. For the FY 2021 dry season storm event, two (2) samples were collected at the Alameda location and both lab results were below the primary contact-single sample Pueblo of Isleta and Pueblo of Sandia WQS (88 CFU/100 mL).

Monthly geometric mean values were not calculated and compared to applicable WQS because the CMC had only one (1) to two (2) samples per location. As a reminder, in January 2017 the CMC members clarified with NMED that the units MPN/100 mL and CFU/100 mL are considered to be interchangeable for the purposes of this stormwater quality monitoring reporting. The New Mexico and Pueblo WQS for E. coli are currently in units of CFU/100 mL while the lab reports are typically in units of MPN/100mL. The graph presented in this section uses units of CFU/100 mL to be consistent with the WQS units. Refer to Figure 2 for a graphical representation of E. coli results from April 2021.

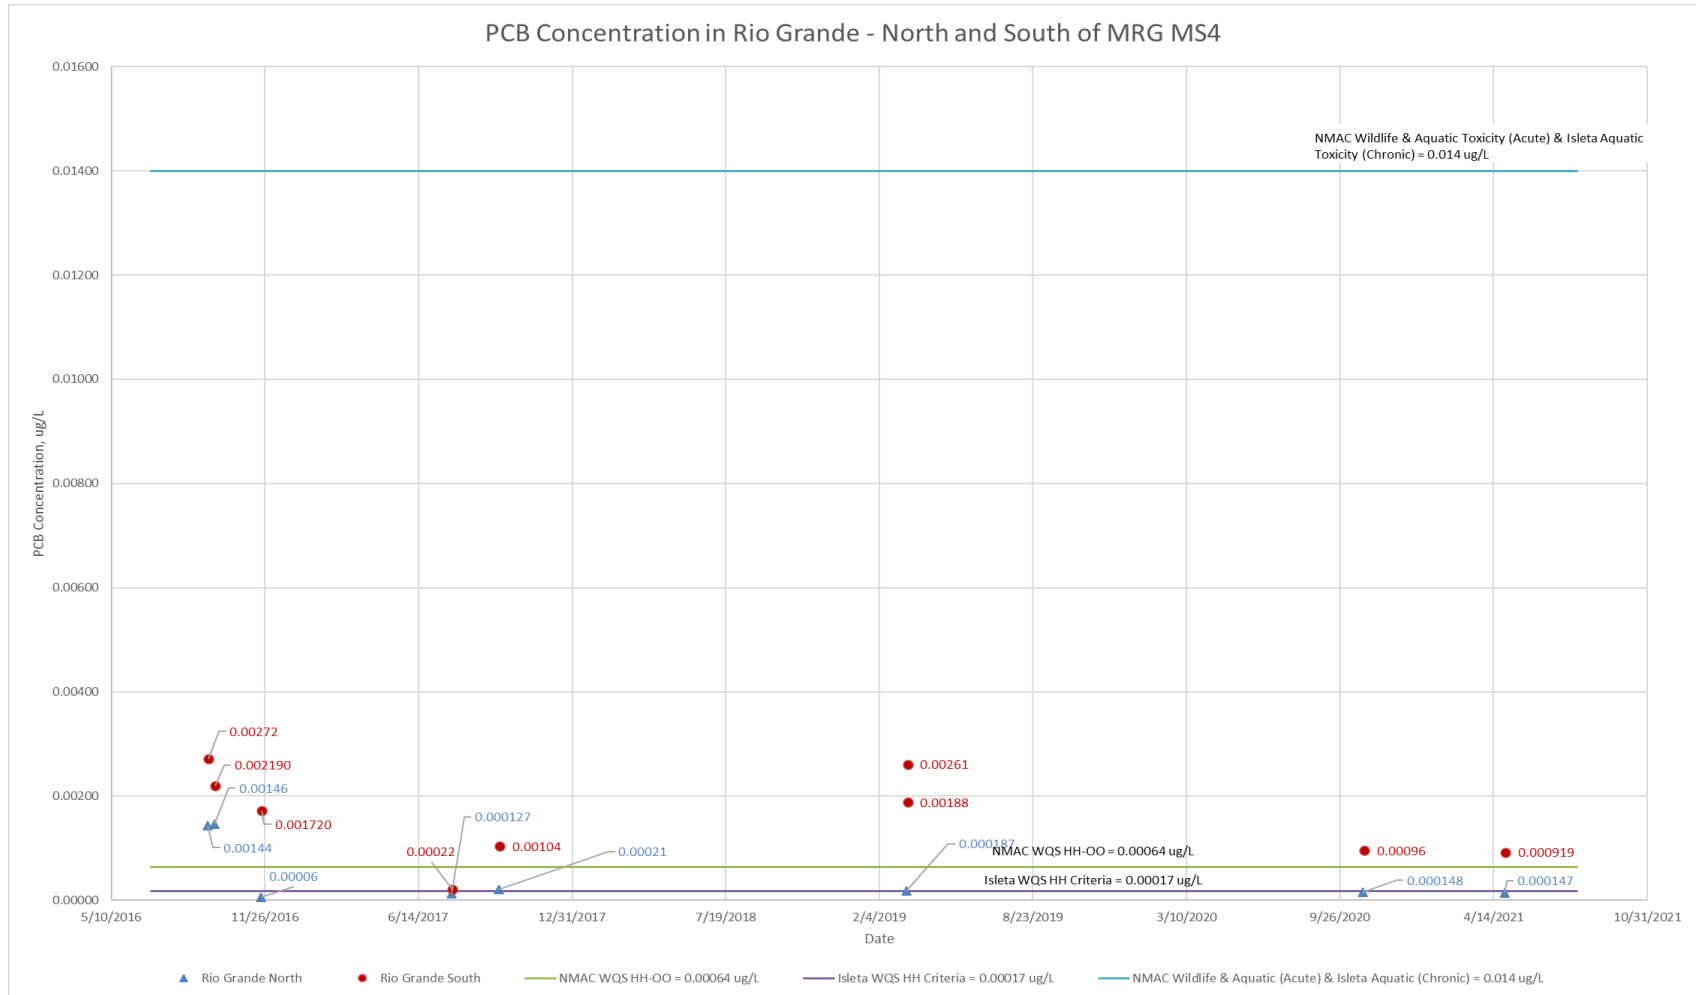
**Figure 3: PCB Monitoring Results in Rio Grande  
 CMC Monitoring – 2016 - 2021**

There are multiple surface WQS values listed for PCBs in both the Pueblo of Isleta and the State of New Mexico standards for the various designated uses. The PCBs measured in samples collected from the Rio Grande during the FY 2021 dry season stormwater event were all below the minimum quantification level (MQL) established in EPA standards for the MS4 NPDES Permit (Appendix F, 0.2 ug/L for PCBs). The PCB results were also well below the New Mexico Surface WQS and Pueblo of Isleta Surface WQS for designated uses including drinking water (0.5 ug/L) and wildlife habitat, acute aquatic life, and chronic aquatic life (0.014 ug/L). However, the CMC sample from the Rio Grande South location was above the Pueblo of Isleta human health criteria (based on fish consumption only) WQS for surface waters. The human health-organism only criterion is based upon human consumption of fish and other aquatic life that bioaccumulate contaminants over time. The PCB results from 2016 through 2021 are shown in Figure 3 relative to several of the WQSs for PCBs.

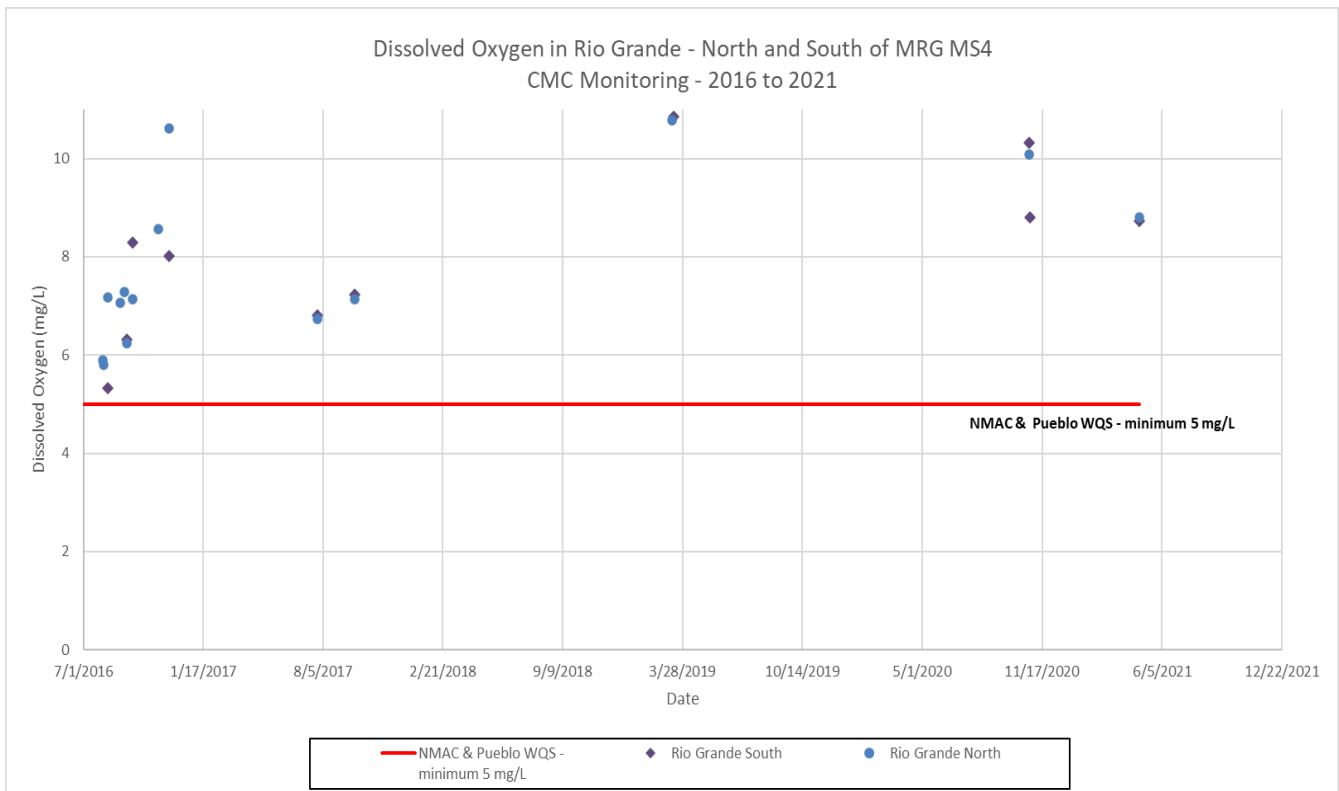
**Figure 4: Dissolved Oxygen Results in Rio Grande CMC Monitoring – 2016 - 2021**

Dissolved oxygen is a water quality concern in the Rio Grande if it is below 5 mg/L. None of the samples taken from the Rio Grande during the FY 2021 dry season monitoring had dissolved oxygen values below 5 mg/L. This provides the MS4s with specific monitoring data showing that stormwater did not cause or contribute to exceedances of applicable dissolved oxygen water quality standards in the Rio Grande from any of the CMC samples from 2016 to 2021. Refer to Figure 4 for CMC dissolved oxygen results and comparison to applicable WQS.

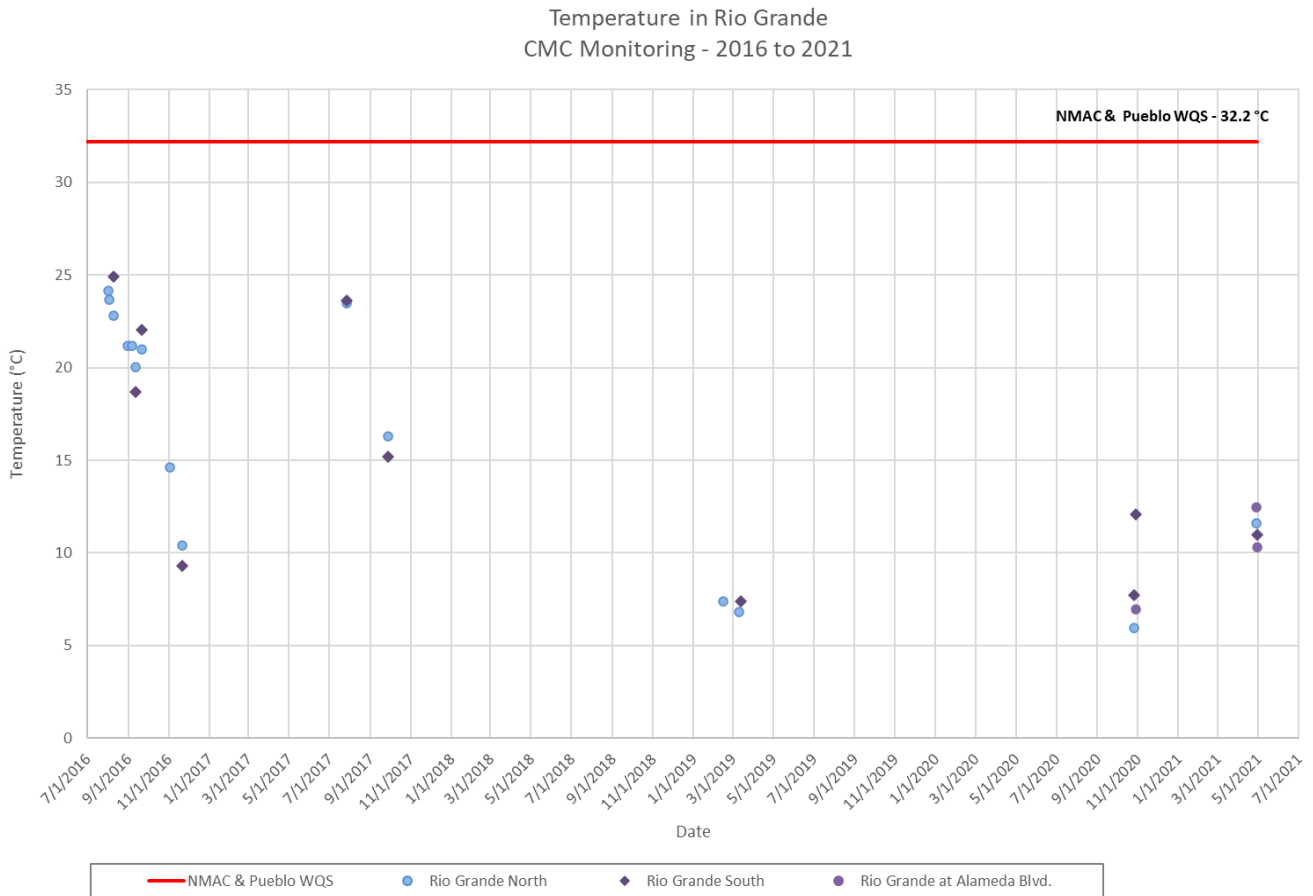
**Figure 5: Temperature Monitoring Results in Rio Grande CMC Monitoring – 2016 - 2021**

Temperature is listed in the WSB MS4 Permit as a special condition (currently only applicable to the City of Albuquerque and AMAFCA). Past data submitted to EPA and NMED by the MS4 permittees have proven that stormwater discharges into the Rio Grande are not raising the Rio Grande temperature above the WQS. The data collected during this FY 2021 dry season monitoring also supports this conclusion. All the temperature field readings taken in the Rio Grande during the CMC FY 2021 dry season were below 32.2°C (90°F) - the WQS for the State of

New Mexico and for the Isleta and Sandia Pueblos. Refer to Figure 5 for temperature results and comparison to applicable WQS for all CMC samples taken upstream and downstream of the MRG MS4 area from 2016 to 2021.

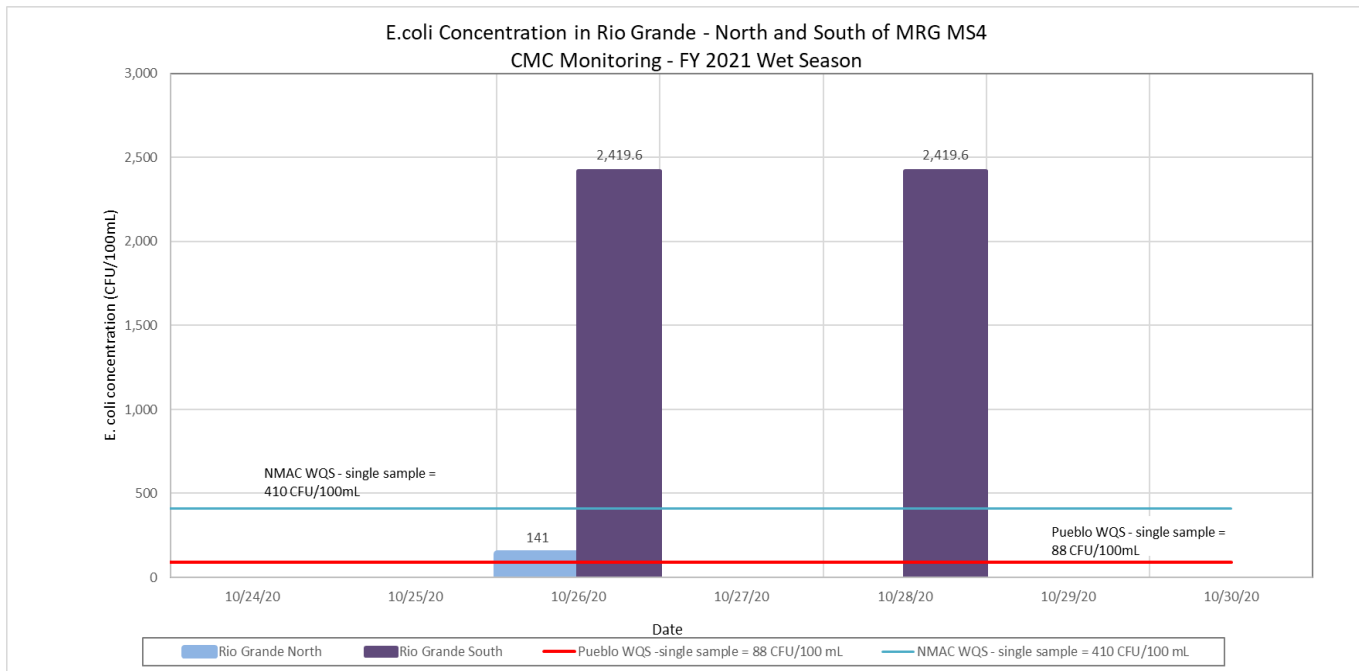
**Figure 2: E. coli Results in Rio Grande CMC Monitoring – FY 2021 Wet Season**

In addition, the CMC added an E. coli sample point in the Rio Grande at Alameda. This added analysis point was based on discussions with NMED in February 2017 on collecting actual data at the stream segment divide verses using an area percentage (as defined in the TMDL) for E. coli loading calculations. For the FY 2021 wet season storm event, a sample was collected at the Alameda location and the lab result exceeded the primary contact-single sample Pueblo of Isleta and Pueblo of Sandia WQS (88 CFU/100 mL), but was below the primary contact-single sample NMAC WQS (410 CFU/100 ml).

**Monthly geometric mean values were not able to be calculated and compared to applicable WQSs because the CMC had only one (1) sample per location.** As a reminder, in January 2017 the CMC members clarified with NMED that the units MPN/100 mL and CFU/100 mL are considered to be interchangeable for the purposes of this stormwater quality monitoring reporting. The New Mexico and Pueblo WQS for E. coli are currently in units of CFU/100 mL while the lab reports are typically in units of MPN/100mL. The graph presented in this section uses units of CFU/100 mL to be consistent with the WQS units. Refer to Figure 2 for a graphical representation of E. coli results from October 2020.
