Annual Stormwater Report

December 2023 | MS4 Permit # NMR04A000

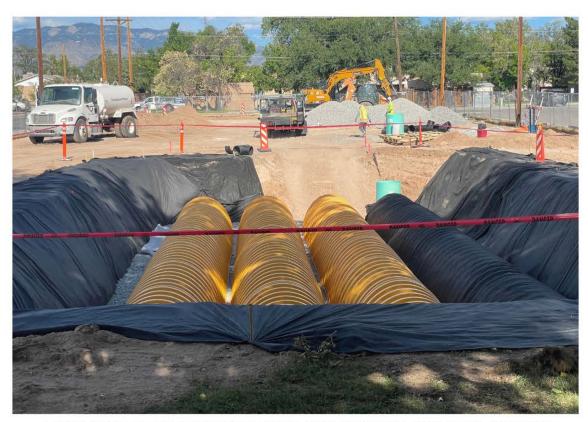
A NEWLY INSTALLED RAINWATER INFILTRATION SYSTEM UNDER THE PARKING LOT OF THE REDESIGNED CRISIS TRIAGE CENTER AT UNM HEALTH SCIENCES.

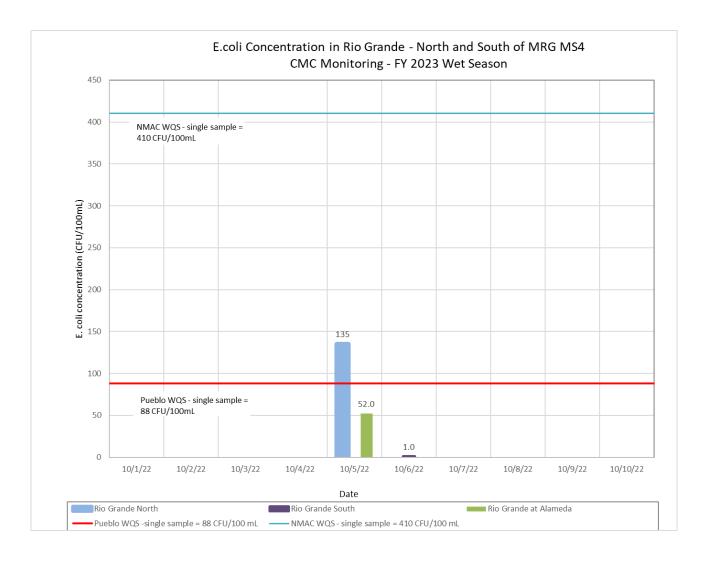
Figure 2: E. coli Results in Rio Grande CMC Monitoring – FY 2023 Wet Season

In addition, the CMC collected one (1) E. coli sample in the Rio Grande at Alameda Blvd. during the FY 2023 wet season. The Alameda Blvd. analysis point was based on discussions with NMED in February 2017 on collecting actual E. coli data at the stream segment divide verses using an area percentage (as defined in the TMDL) for E. coli loading calculations. The lab results showed that the sample had an acceptable E. coli concentration below the primary contact-single sample Pueblo of Isleta WQS (88 CFU/100 mL) and the primary contact-single sample NMAC WQS (410 CFU/100 mL).

As a reminder, in January 2017 the CMC members clarified with NMED that the units MPN/100 mL and CFU/100 mL are considered to be interchangeable for the purposes of this stormwater quality monitoring reporting. The New Mexico and Pueblo WQSs for E. coli are currently in units of CFU/100 mL while the lab reports are typically in units of MPN/100mL. The graph presented in this section uses units of CFU/100 mL to be consistent with the WQS units. Refer to Figure 2 for a graphical representation of E. coli results from October 2022.

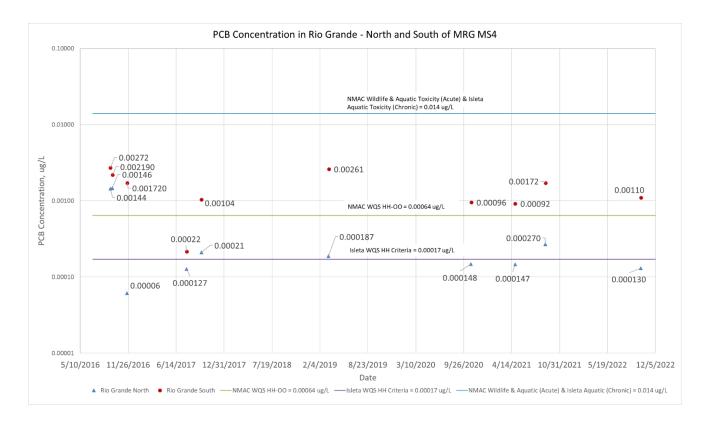
Figure 3: PCB Monitoring Results in Rio Grande CMC Monitoring – 2016 - 2022

There are multiple surface WQS values listed for PCBs in both the Pueblo of Isleta and the State of New Mexico standards for the various designated uses. The PCB results for samples collected from the Rio Grande during the FY 2023 wet season stormwater event were below the minimum quantification level (MQL) established in EPA standards for the MS4 NPDES Permit (Appendix F, 0.2 ug/L for PCBs). The PCB results for the Rio Grande North sample were also well below the New Mexico Surface WQSs and Pueblo of Isleta Surface WQSs for designated uses including drinking water (0.5 ug/L) and wildlife habitat, acute aquatic life, and chronic aquatic life (0.014 ug/L). However, the CMC sample from the Rio Grande South location was above the Pueblo of Isleta human health criteria (based on fish consumption only) WQS for surface waters. The human health-organism only criterion is based upon human consumption of fish and other aquatic life that bioaccumulate contaminants over time. The PCB results from 2016 through 2022 are shown in Figure 3 relative to several of the WQSs for PCBs.

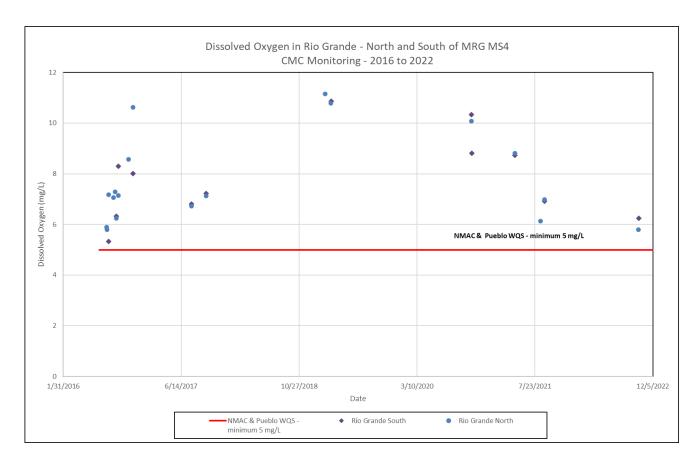
Figure 4: Dissolved Oxygen Results in the Rio Grande CMC Monitoring – 2016 - 2022

Dissolved oxygen is a water quality concern in the Rio Grande if it is below 5 mg/L. None of the samples taken from the Rio Grande during the FY 2023 wet season monitoring had dissolved oxygen values below 5 mg/L. This provides the MS4s with specific monitoring data showing that stormwater did not cause or contribute to exceedances of applicable dissolved oxygen water quality standards in the Rio Grande from any of the CMC samples from 2016 to 2022. Refer to Figure 4 for CMC dissolved oxygen results and comparison to applicable WQSs.

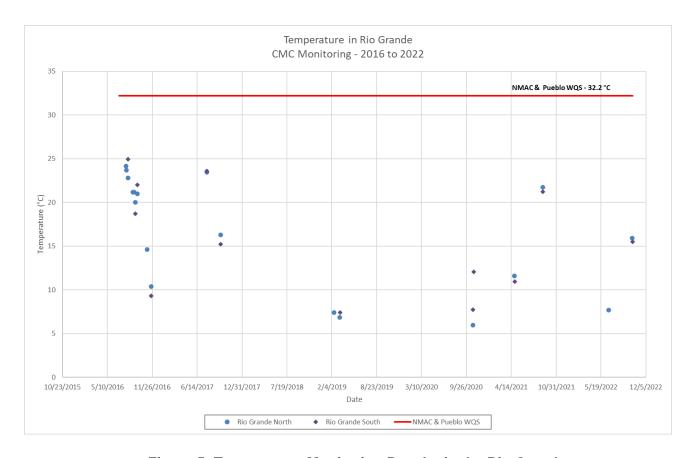
Figure 5: Temperature Monitoring Results in the Rio Grande CMC Monitoring – 2016 - 2022

Temperature is listed in the WSB MS4 Permit as a special condition (currently only applicable to the City of Albuquerque and AMAFCA). Past data submitted to EPA and NMED by the MS4 permittees have proven that stormwater discharges into the Rio Grande are not raising the Rio Grande temperature above the WQSs. The data collected during this FY 2023 wet season monitoring also supports this conclusion. All the temperature field readings taken in the Rio Grande during the CMC FY 2023 wet season were below 32.2°C (90°F), which is the WQS for the State of New Mexico and for the Isleta and Sandia Pueblos. Refer to Figure 5 for temperature results and comparison to applicable WQSs for all CMC samples taken upstream and downstream of the MRG MS4 area from 2016 to 2022.
